# Environmental cost of flooding

A report by URBED (Urbanism Environment and Design) Ltd as part of the Big Lottery funded 'Rebuilding Together' project in Cumbria.

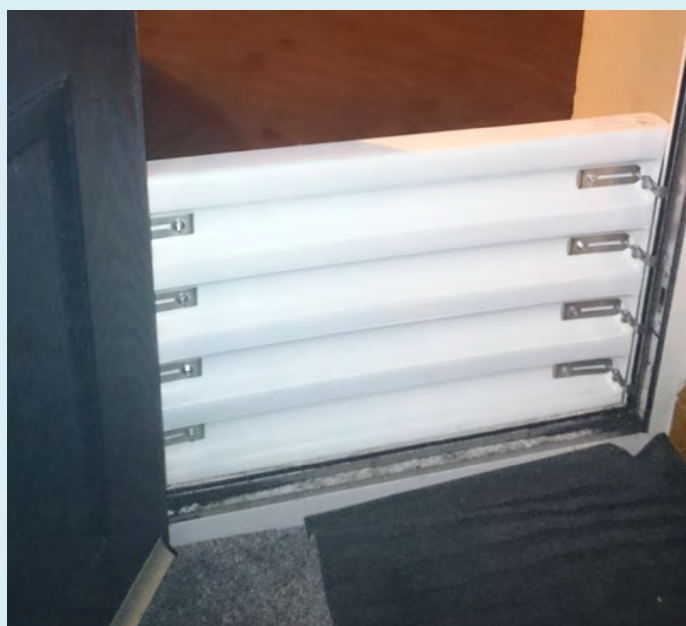
Above: flood doors fitted by previous owner

In the event, the flood gates offered little protection, as water found its way through cracks in the wall and other routes and eventually over-topped them. One of the flood gates (to the most critical rear elevation) appeared to fail as it had been badly fitted. The house has solid floors, so water coming up through the floor was not a factor.

This was the first time this householder had experienced a flood event, though they were aware of the risk due to previous events in the same area. The house had been fitted with flood gates (to front and back doors) by the previous owner, but little other work had been undertaken to their knowledge.

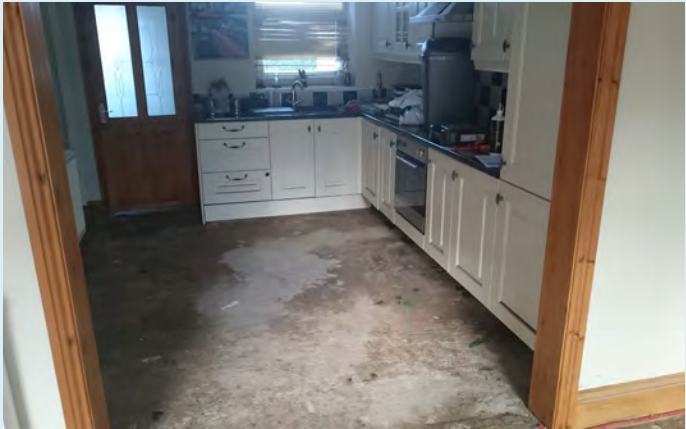
Tiles in the kitchen floor were stripped out and replaced.

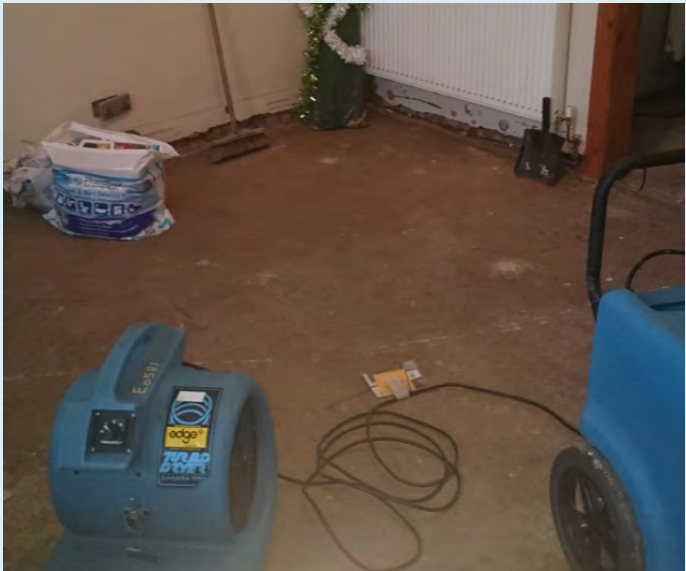
Drying out was by electric heaters and dehumidifiers.

Drying out was undertaken with electric heaters and electrically powered dehumidifiers, supplied by the contractor. The process took around a month and used a

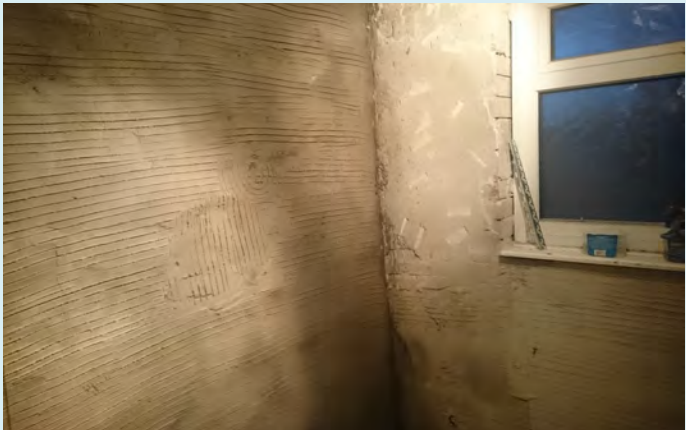
Bathroom tiles were also removed and replaced.

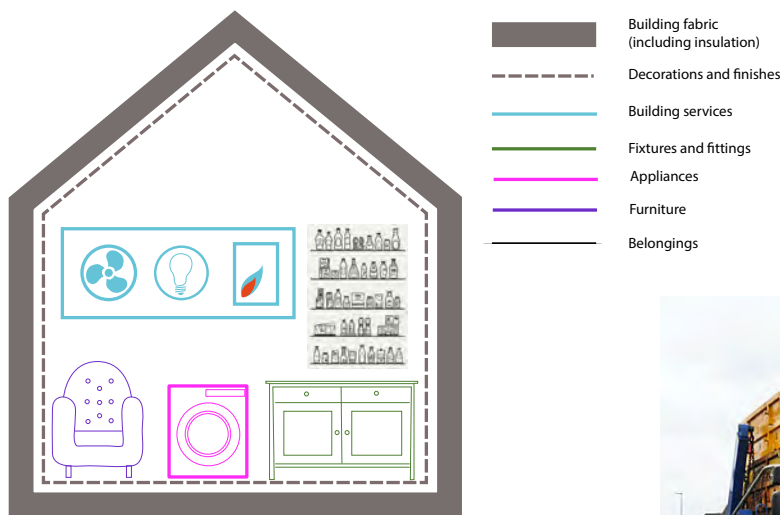
Above: Any home contains layers or construction and materials, all of which behave differently and need to be treated differently in any flood recovery process.

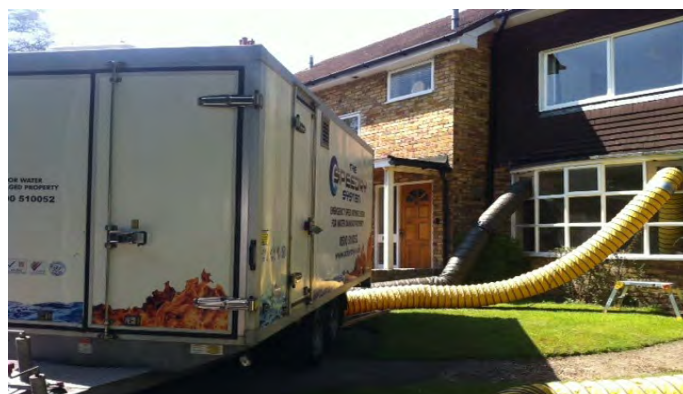
Above: speed drying trailer

Speed drying systems are typically mobile trailer units designed to heat multiple rooms to over 60°C. As independent units they are not reliant on the existing heating or electrical system of the home. Whilst this may reduce electricity costs to the householder, and may also mean the process can start more quickly - saving subsequent damage from prolonged dampness - they use diesel or petrol generators for power. These emit particulates and carbon monoxide which contribute to poor local air quality and create noise. The main unit usually pumps heat to smaller heat exchangers throughout the home; which usually have a power rating of 10, 30 or 60kW (ISS Restoration, online). The power used by such systems is therefore considerable.

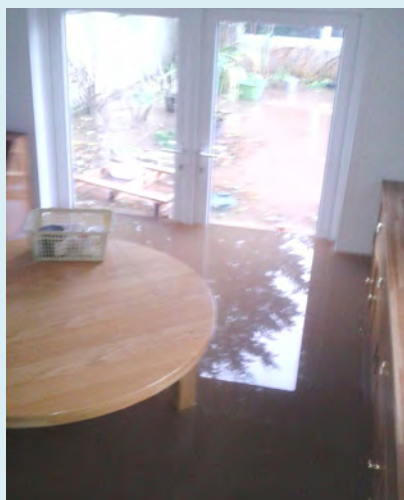
Right:  
The flood water reached 1.3m at the rear of the house.

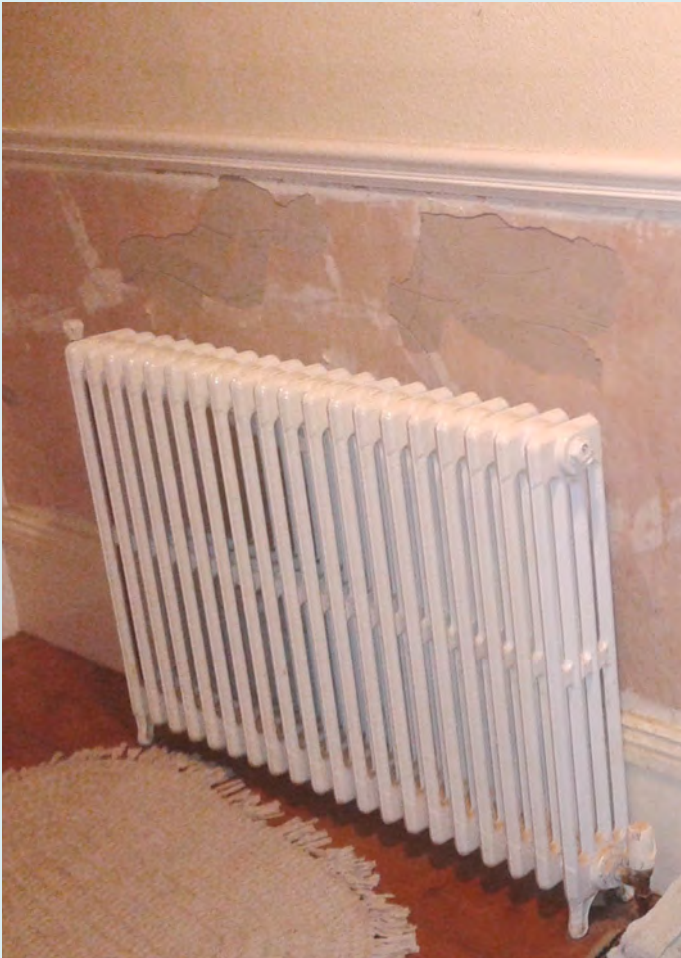
Some areas of skirtings, such as behind radiators, were not removed.

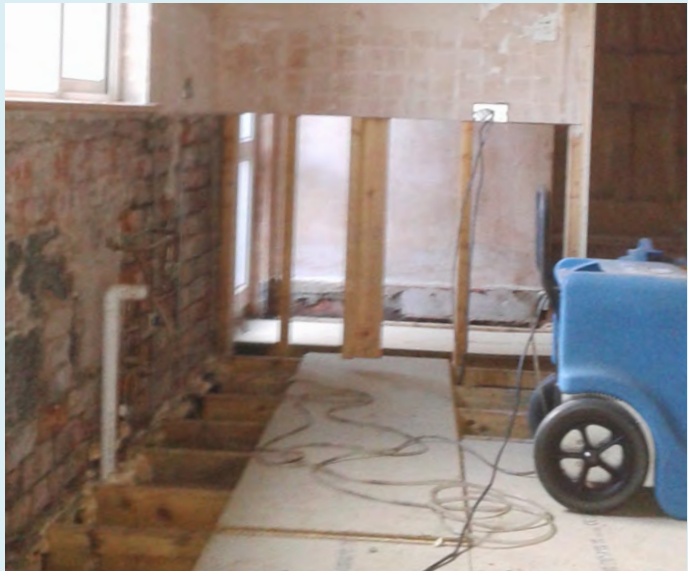
Drying out was by the gas central heating and dehumidifiers.

As the householder was able to live upstairs, the impetus to get the house dry quickly was perhaps reduced compared to those who had moved out. They were also conscious of the porous nature of older building materials, and the need to dry the house slowly so that the timber floor and other elements were not adversely affected. The fact that the central heating was back up and running promptly after the flood helped in this.

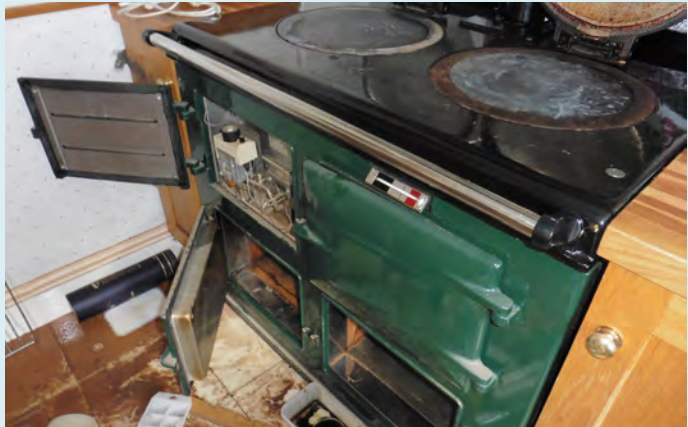
The AGA had to be replaced again after showing signs of rust.
